Damariscotta Lake Watershed Protection Plan | 2015

Report Prepared By:
Garrison Beck
Program Director
Damariscotta Lake Watershed Association
May 2015

DAMARISCOTTA LAKE WATERSHED SURVEY REPORT

**Damariscotta Lake
Watershed Association**

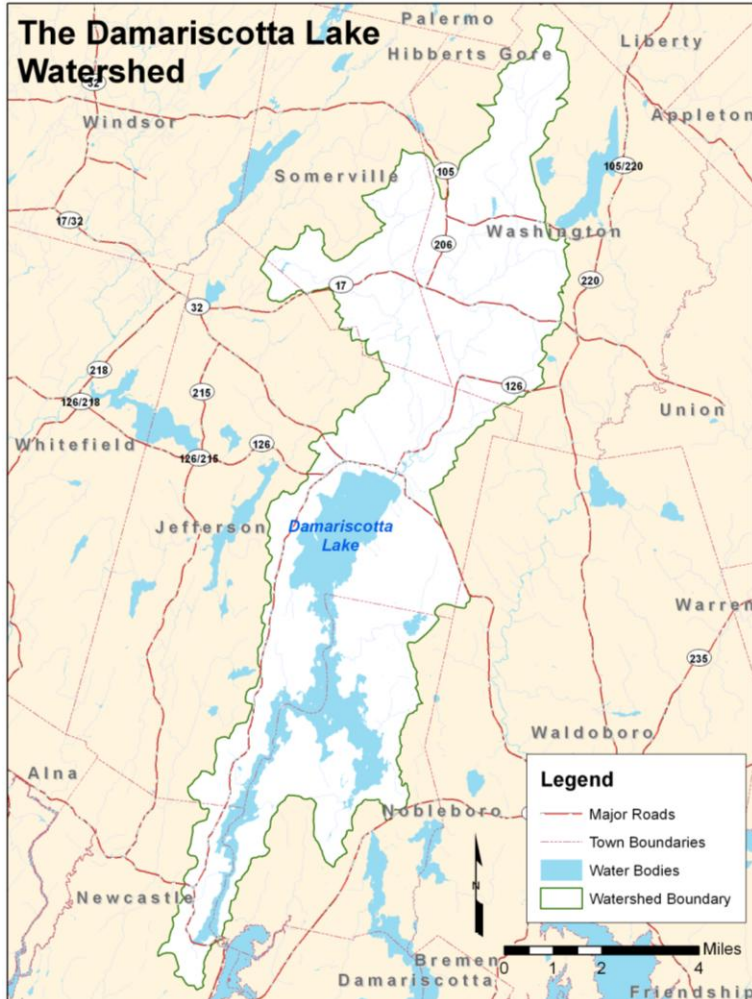
Figure 1. The Damariscotta Lake Watershed

Damariscotta Lake is located within the towns of Jefferson, Nobleboro, and Newcastle, while the Watershed extends to the towns of Somerville, Washington, and Waldoboro (Figure 1). The Lake has an approximate surface area of 4,686 acres and the watershed encompasses 56.8 square miles. Damariscotta Lake has three true basins: Great Bay in the north, Muscongus Bay in the south-east, and the South Basin or South Arm in the south-west, which leads to the outlet of the lake. The Damariscotta Lake State Park is located on the north shore of the lake and provides public day use facilities and access to a sand beach on Damariscotta Lake.

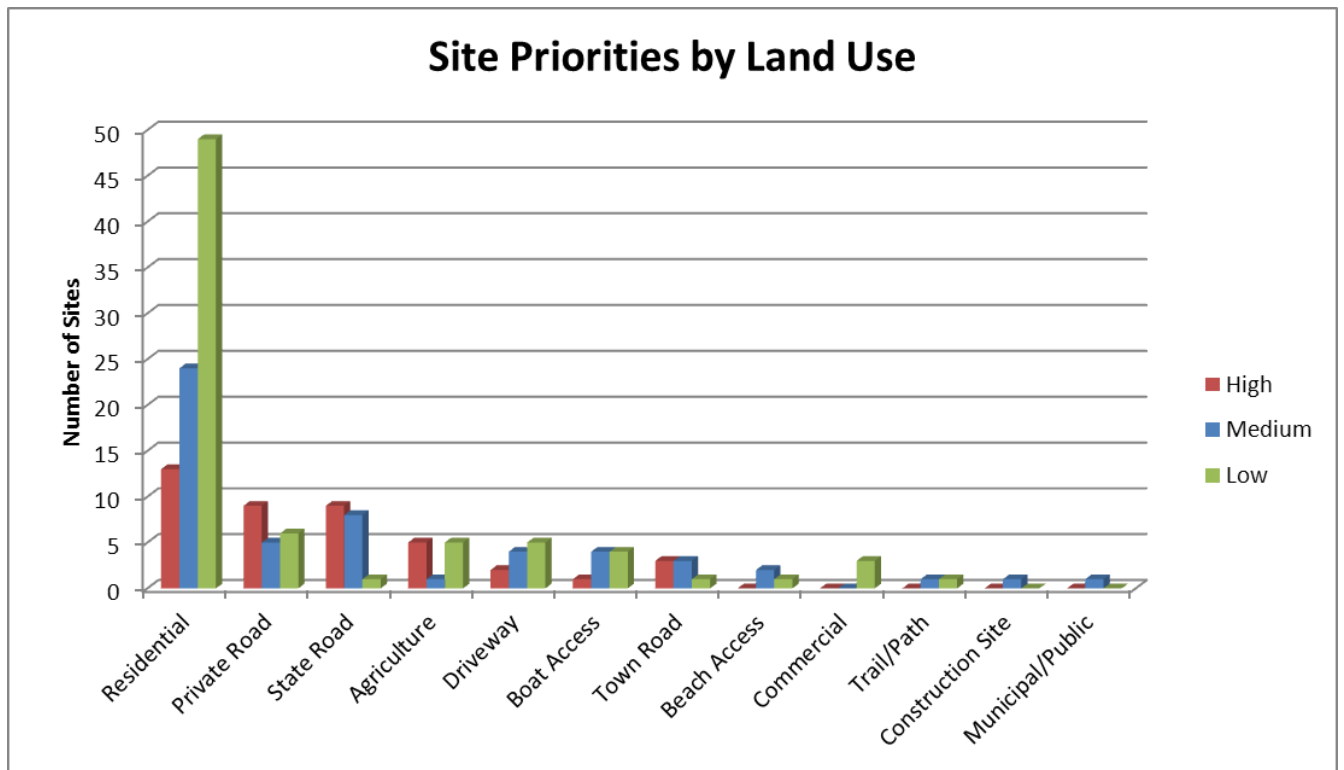
Figure 2. NPS sites categorized by land use and priority ranking

Within the Damariscotta Lake Watershed, 172 sites were identified as contributing Nonpoint Source Pollution to Damariscotta Lake. The majority (86 sites, 50%) of NPS sites were found on residential land uses. The second most common land use was on private roads at only 12% (20 sites). The next most common source of NPS sites were on state roads (18 sites), agricultural land uses (11 sites), and driveways (11 sites). Table 1 details all land uses and the associated number of NPS sites documented, as well as the relative level of priority for each site, rated by the impact to water quality, estimated cost to fix, and estimated technical level to fix each site. High priority sites are those which have the most impact on water quality and are the most expensive and technically demanding to fix. Low priority sites are often those which have low water quality impact and low costs, making them relatively easy for landowners to fix with some guidance and reference materials. Figure 2 displays these same data graphically.

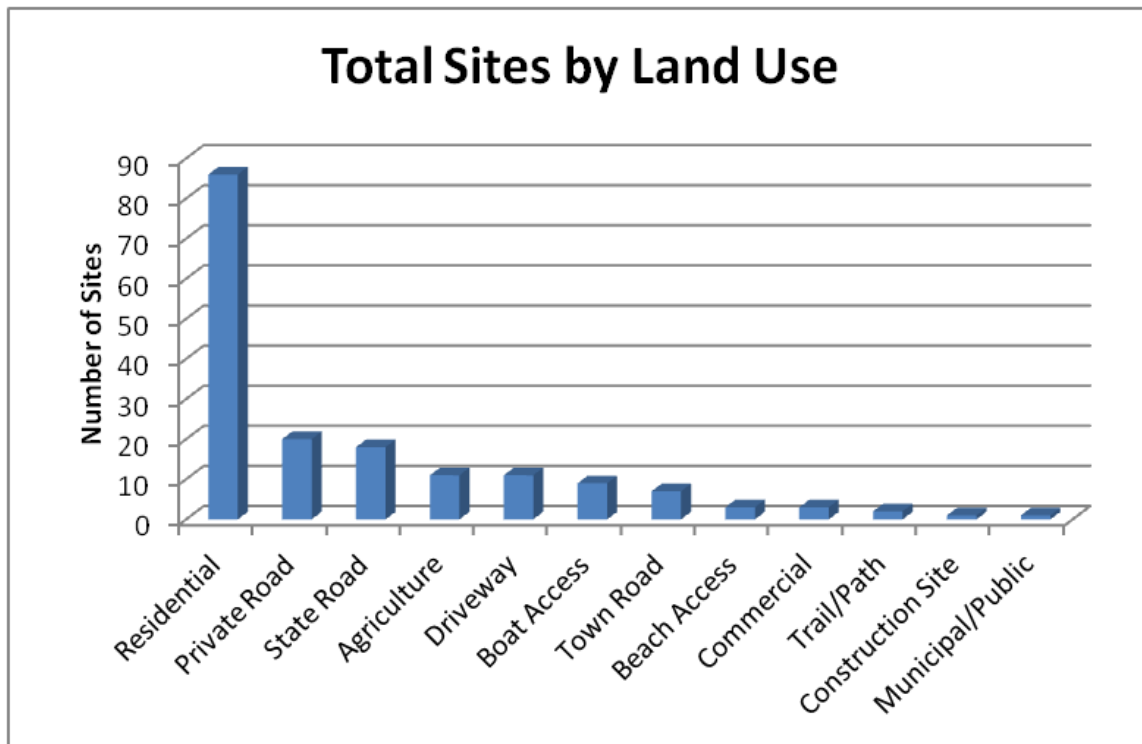
Figure 3. Total number of NPS sites organized by land use

The majority (50%) of NPS sites were found on residential land uses, a total of 86 sites. The second most common land use was on private roads, shadowing the residential sites at only 12% of all sites. Figures 3 and 4 show all sites organized by land use, as total number of sites and percentage of total sites, respectively. Roads in general are the second leading source of NPS pollution in the watershed, with private roads, state roads, town roads, and driveways accounting for 33% of all NPS sites (Figure 5).

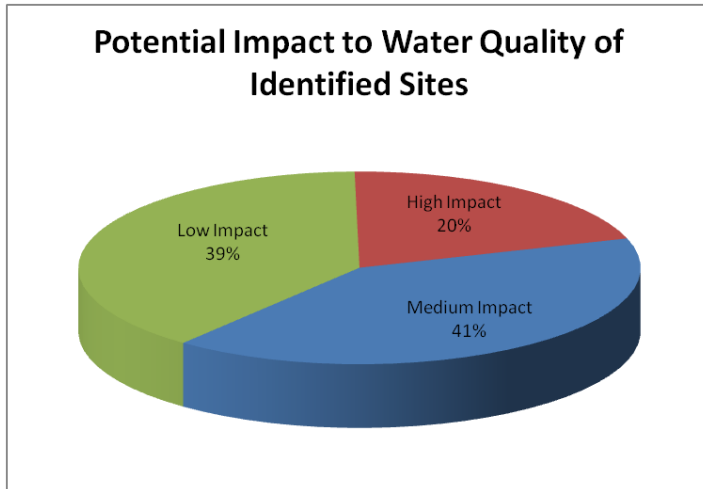
In the field, all sites were assessed based on the estimated impact each site would have on water quality using three factors to determine a rating of high, medium, or low impact. 20% of sites were determined to be high impact sites.

- Type of erosion: sheet, rill, or gully, increasing in terms of severity
- Area: small, medium, or large
- Buffers and Filtering: Significant buffer or filter, some buffer or filter, and no filter

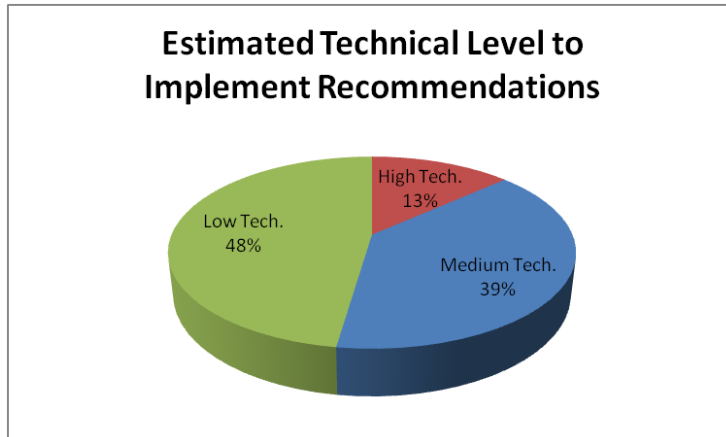
Finally, each site was rated on the estimated degree of technical expertise that would be required to implement the recommendations. 48% of sites were estimated as needing no technical expertise, those which may be accomplished by a reasonably capable homeowner.

- High: Site requires engineered design
- Medium: Technical person should visit site and make recommendations
- Low: Property owner can accomplish with reference materials

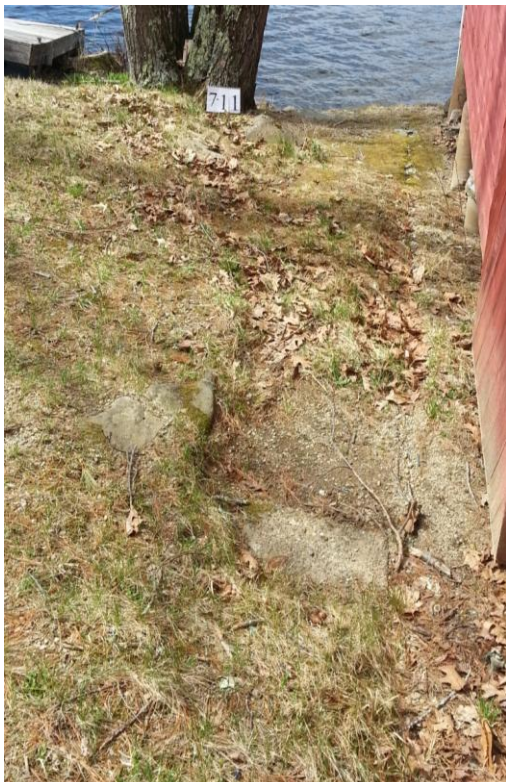
Below is one example of a residential site that was documented during this Watershed Survey. Included are the problems and recommendations that are suggested for this specific site. This is also representative of a residential site as it is relatively easy to fix at a low cost.

- Moderate surface erosion
- Bare/exposed soil
- Roof runoff erosion
- Lack of buffer vegetation

- Infiltration trench at roof dripline
- Establish a vegetated buffer
- Mulch and/or erosion control mix
- Reseed bare soil

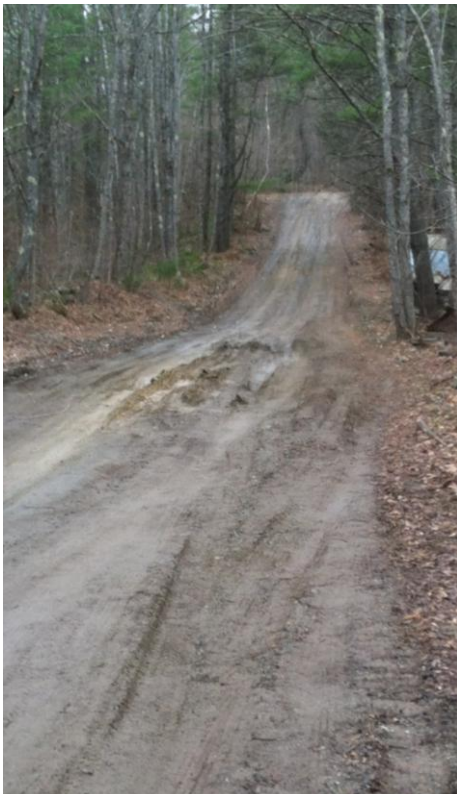
Below is one example of a road site that was documented during this Watershed Survey. Included are the problems and recommendations that are suggested for this specific site.

- Severe surface erosion along road, in part due to steep slope
- Water accumulates, causing ruts
- Lack of road crown or ditching
- Minimal buffer between road and lake (not pictured)

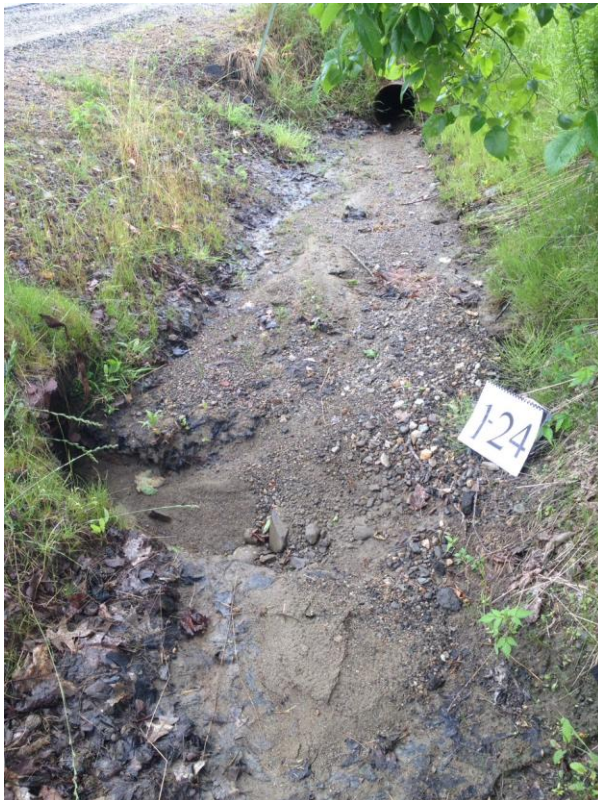
Below is one example of a state road site that was documented during this Watershed Survey. Included are the problems and recommendations that are suggested for this specific site.

- Severe ditch and road shoulder erosion
- Accumulation of sediment in ditch
- Undersized culvert
- Flow directly into stream (not pictured)

- Armor and/or vegetate ditch and road shoulder
- Remove debris/sediment
- Replace and enlarge culvert
- Install check dams or sediment pools
